Structural Assessment of Ully Hovli in Uzbekistan by Laser Scanning: Preliminary Results

AIPCP25-CF-ASWEE2025-00033 | Article

Abstract. The paper is focused on the structural assessment of the ancient monument in the Khorezm region of Uzbekistan. A historic fortress, "Uly Hovli," was studied. A terrestrial laser scanner was used to collect information about it. The laser scanner produced the so-called point cloud containing detailed information about its current geometry, including all imperfections and possible structural anomalies. The point cloud was investigated for two walls. One of the walls—the front wall on the right side of the main entrance—was fully reconstructed during the recent restoration effort. The analysis conducted during this study showed that this wall mimics the taper common to this type of construction from untreated earthen materials, called pakhsa. It was shown that this wall has a much more regular structure than the inner wall, which was preserved with very limited alterations. It was shown that this inner wall has an irregular structure, with large indentations that reduce its thickness. This paper discusses the preliminary results of the analysis. The

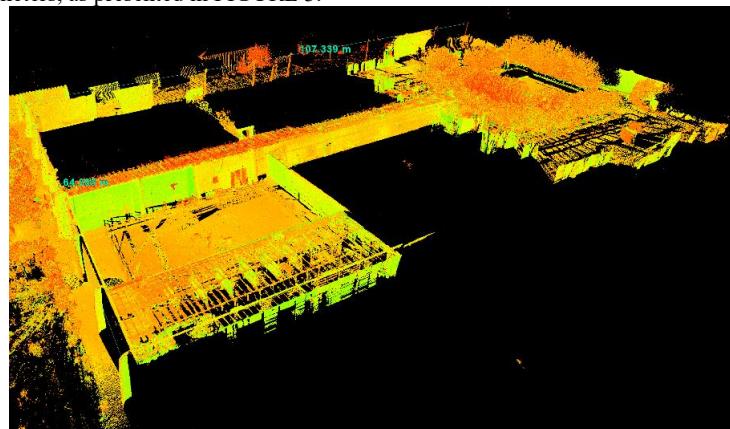
The monument's overall dimensions in a plan view are close to a rectangle with a length of close to 107.3 meters and a width of 64.3 meters, as presented in FIGURE 3.

FIGURE 3. The overall dimensions of the monument

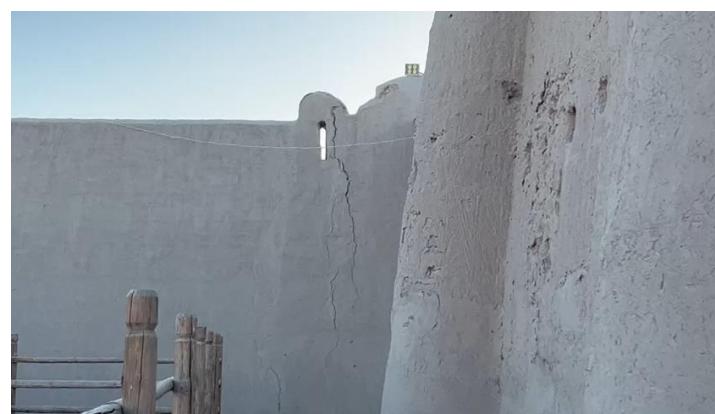
As mentioned earlier, the monument underwent a recent restoration. During the laser-scanning project, it was observed that a small courtyard that is dedicated as a stable for traditional animals has walls with limited restoration signs, as presented in FIGURE 5.

FIGURE 5. The wall of a small courtyard with limited restoration signs (on the right side of the image)

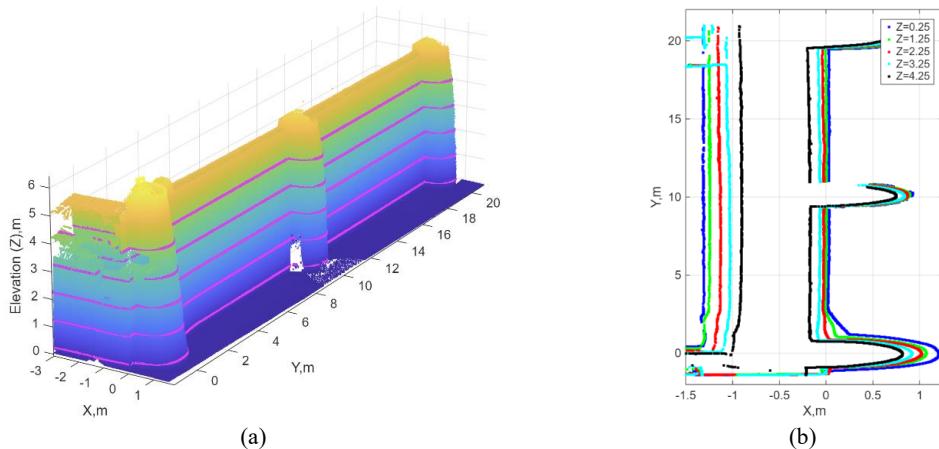
Based on the condition of the monument before reconstruction [10], the front wall on the right side of the main entrance was fully rebuilt. This wall is investigated in more detail in this section of the paper. A few horizontal slices of the wall's point cloud were investigated as presented in FIGURE 6a. The plan views of the respective sections are presented in FIGURE 6b. As shown in the latter image, the wall width increases gradually with elevation. It is quite common in pahska construction. The wall's taper on the inside of the monument is larger than that on the front side. This conclusion is more visible in the vertical sections of the wall, which are shown in fig. 7.

FIGURE 6. The horizontal sections of the monument's front wall on the right side of the main entrance (a), and plan views of the sections (b)

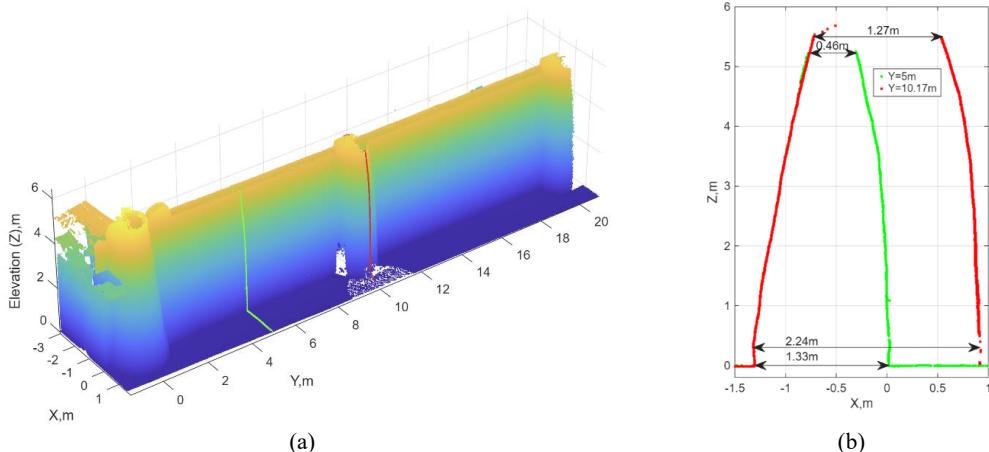
Fig. 7a shows an isometric view of the wall with two vertical slices marked by red and green. The elevation views are presented in fig. 7b. It shows that the wall thickness varies from 1.33 m at the bottom to 0.46 m at the very top. The thickness of the tower (shown in red) is much larger than that. It varies from 2.24 m at the bottom of the tower to 1.27 m at its top. Since it is a modern construction, the wall thickness is very consistent along its length, as shown in the plan view sections of fig. 6b. That is why only vertical sections are shown in fig. 7 as representative examples. The exterior walls are about 5.5 m tall.

FIGURE 7. Two vertical sections of the monument's front wall on the right side of the main entrance (a), and elevation views of the sections (b)

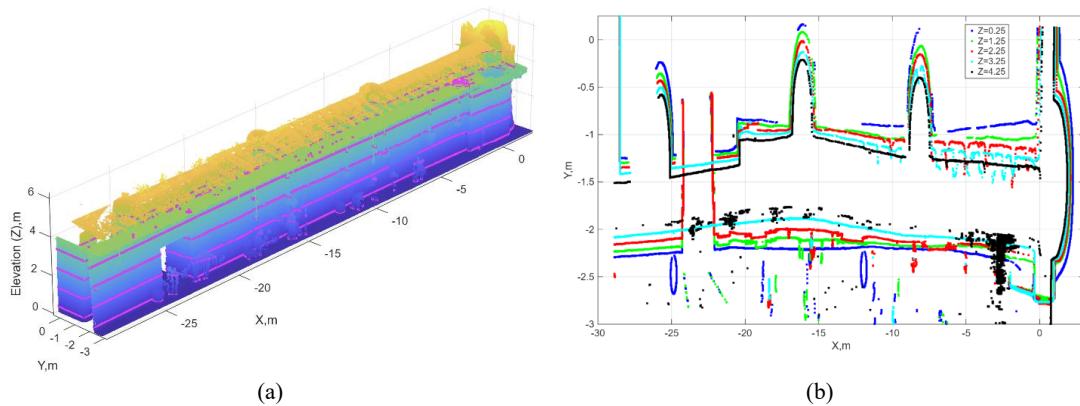
The inner wall on the right side of the corridor still has some signs of wear and tear, as discussed (see discussion related to fig. 5). This wall was also investigated by analyzing its horizontal and vertical slices. The results for horizontal sections are presented in fig. 8. The image on the right shows an isometric 3D view of the wall, with the horizontal sections shown in magenta. The image on the right shows the plan views of these sections. As shown in fig. 8b, the plan view changes significantly along the X axis. In addition, the least restored side of the wall (right side of the plot) has several deep indentations.

FIGURE 8. The horizontal sections of the monument's inner wall on the right side of the corridor (a), and plan views of the sections (b)

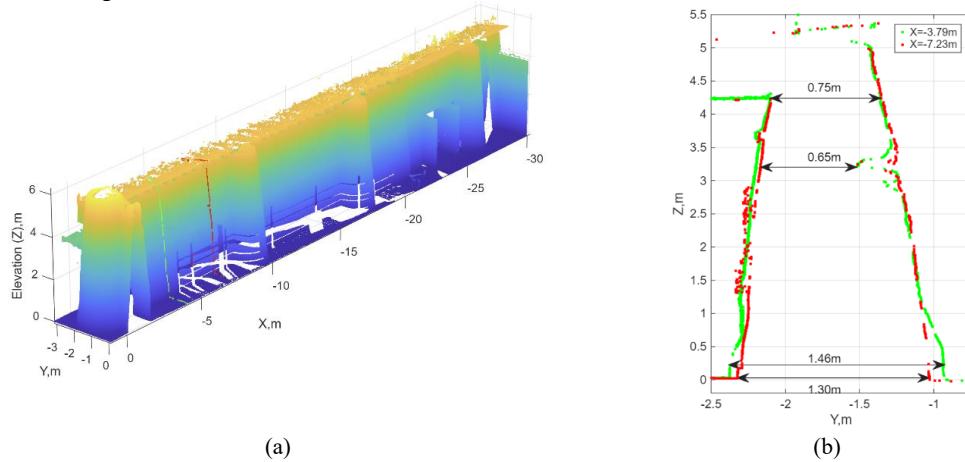
Similar to the outer wall, which was fully reconstructed, the wall has a taper on both sides. It has a smaller taper on the corridor side (the left side of the plot in fig. 9b) but a larger taper on the side of the stables (the right side of the plot in fig. 9b). As shown, the wall thickness varies from about 1.46 m at the bottom of the wall to 0.75 m at its top. The indentations in the wall are quite deep, and in some cases, they reduce the thickness of the wall to 0.65 m as shown in fig. 9b.

FIGURE 9. Two vertical sections of the monument's inner wall on the right side of the corridor (a), and elevation views of the sections (b)
