On Strengthening of Slopes by Gabion Structures

Abstract. Without a high-quality roadbed, it is impossible to construct a modern highway that can maintain the road surface's bearing capacity and evenness over the long term, particularly on weak soils and under varying hydrological and climatic conditions. A notable characteristic of long-distance transport structures, such as highways, is that they traverse areas with different geotectonic formations. For these structures, ensuring their viability (functionality) during operation, maintenance, and resistance to geological influences is a particularly pressing concern. These factors highlight the necessity of developing measures and technologies aimed at constructing roads that boast improved strength characteristics and extended service life, in alignment with international norms and standards. In this issue case study for strengthening are proposed

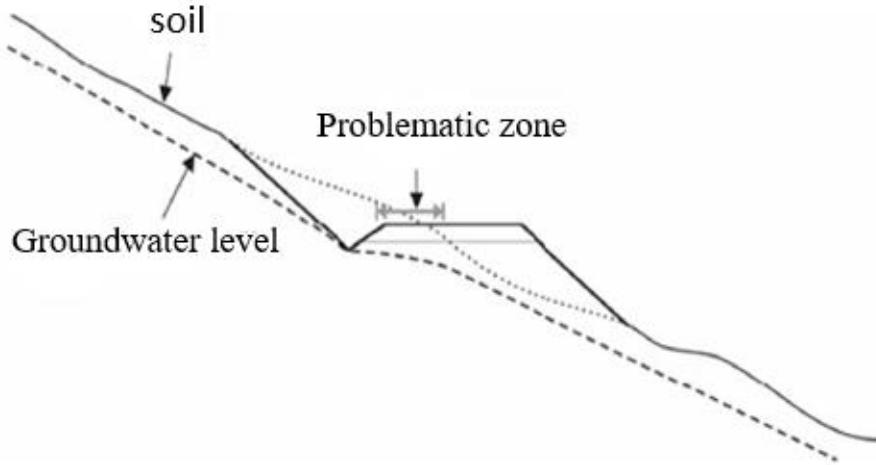
FIGURE 1. Cross-section of a problematic road section

The primary cause of these additional costs is the instability of road structures, which arises from the migration of pressurized groundwater from the excavation into the embankment (fig.1). Depending on the soil and hydrogeological conditions, this can lead to rutting in the excavation area, while landslide deformations and soil subsidence may occur in the embankment. The situation becomes even more complicated if the road section is low-lying, such as crossing a ravine or shallow gully, and features a high embankment, with depressions along both upstream sides of the

longitudinal profile. In such areas, groundwater can migrate in both directions into the foundation of the road structure built atop the high embankment [9-11].

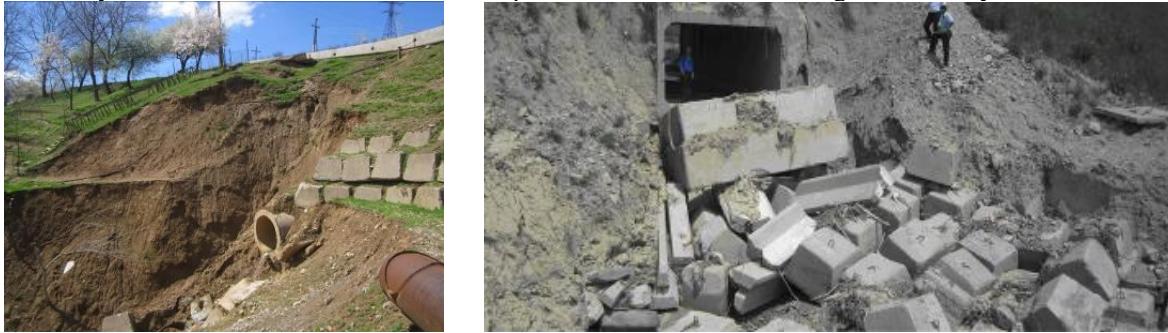
FIGURE 2. Road sections damaged due to loss of foundation bearing capacity, Uzbekistan (Photo by Abirov R.)

Subgrades in excavations and at ground level are less susceptible to earthquakes than those in embankments. As the height (or depth) of the subgrade increases, the level of potential damage escalates. Furthermore, increasing the steepness of the slope—particularly in the case of an oblique slope—significantly reduces the seismic resistance of the subgrade, as illustrated in Figures 2.

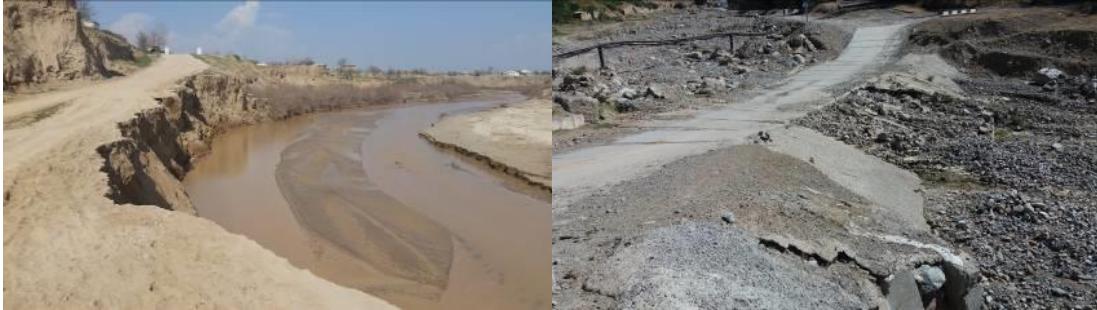
FIGURE 3. Washed out roads (Photo by Abirov R.)

A notable characteristic of localized deformations is that if they continue to develop, they can lead to significant damage (fig. 3).

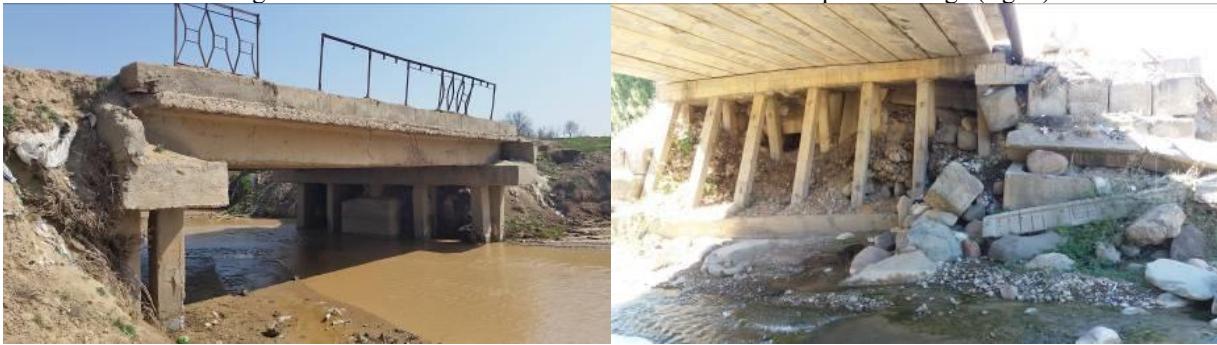
FIGURE 4. Soil subsidence due to insufficient compaction and soil washout from under transition slabs (Photo by Abirov R.)

Soil subsidence and inadequate compaction have led to damage in the approach roadbed and roadway thresholds around the transition slabs. This damage is primarily caused by soil subsidence as a result of insufficient compaction and soil erosion occurring beneath the transition slabs and cross beams due to poor drainage (fig. 4).

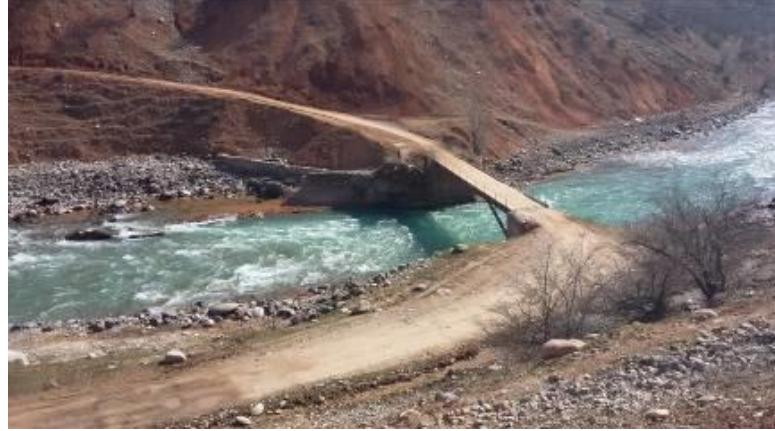
FIGURE 5. General view of the investigated site (Photo by Abirov R.)

Below proposed approach for installation of gabion structures in the working design for the bridge across the Pskem River at the exit to the settlement of "Ispai" from the 4K795 "Chorbog Suv Ombori Aylanma Yuli - Korabulok Village - Pskom Village" highway (fig. 5).

The existing bridge across the Pskem River at the exit to the village of Ispai was built by residents using the "hashar" method. In 2014, due to high water flow and long-term deformation of the riverbank slopes, the foundations of the bridge's bank piers were washed away.

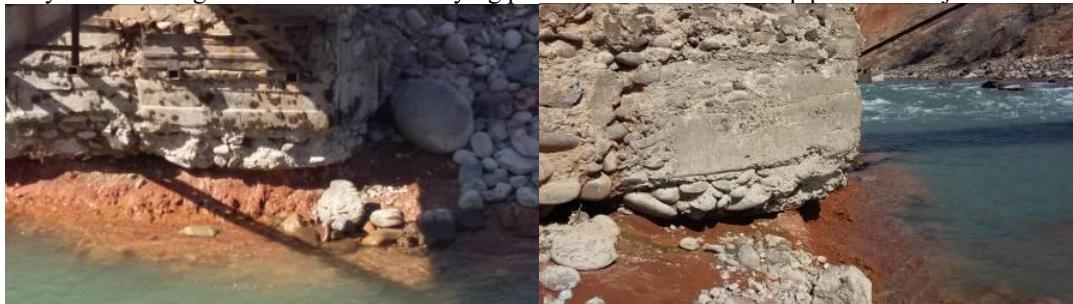
FIGURE 6. General view of the locations and conditions of bridge supports (Photo by Abirov R.)

Following a survey, the bridge was deemed unsafe, and it was proposed to replace the roadway and begin construction of reinforcement structures on the bridge banks (fig. 6).

The design was based on topographic and geodetic data compiled by the survey department of Loyikha Sifat LLC in March 2015. The design envisages the preservation and use of the existing superstructure, with the reinforcement of the bridge banks using gabion boxes. The piers are massive, cantilevered. The existing superstructure consists of composite I-beams with a total height of 77 cm. The distance between the beams is 232.5 cm. The main beams are connected by cross bracing made of corners of varying profiles and horizontal strip plates at the joints.
