# On Strengthening of Slopes by Gabion Structures

Rustam Abirov<sup>1, a)</sup>

<sup>1</sup>*Institute of Mechanics and Seismic Stability of Structures named after M.T. Urazbaev, Uzbekistan Academy of Sciences, Tashkent, Uzbekistan*

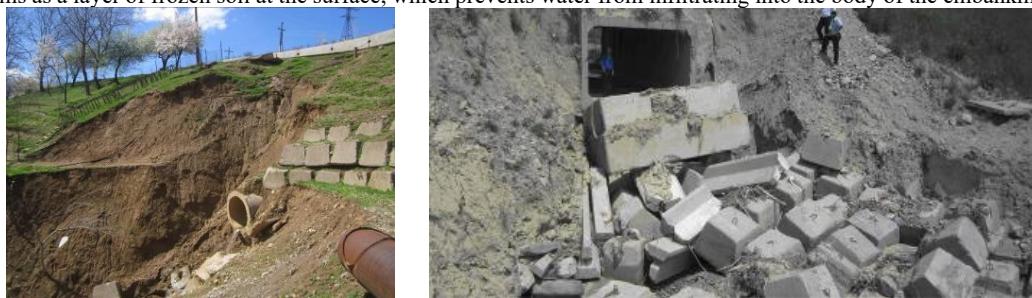
**FIGURE 2.** Road sections damaged due to loss of foundation bearing capacity, Uzbekistan (Photo by Abirov R.)

Subgrades in excavations and at ground level are less susceptible to earthquakes than those in embankments. As the height (or depth) of the subgrade increases, the level of potential damage escalates. Furthermore, increasing the steepness of the slope—particularly in the case of an oblique slope—significantly reduces the seismic resistance of the subgrade, as illustrated in Figures 2.

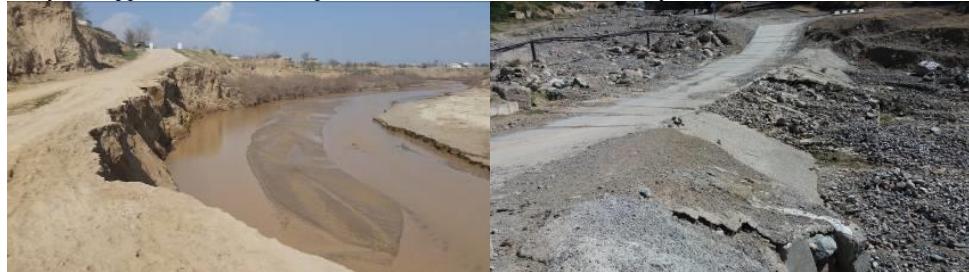
FIGURE 3. Washed out roads (Photo by Abirov R.)

A notable characteristic of localized deformations is that if they continue to develop, they can lead to significant damage (fig. 3).

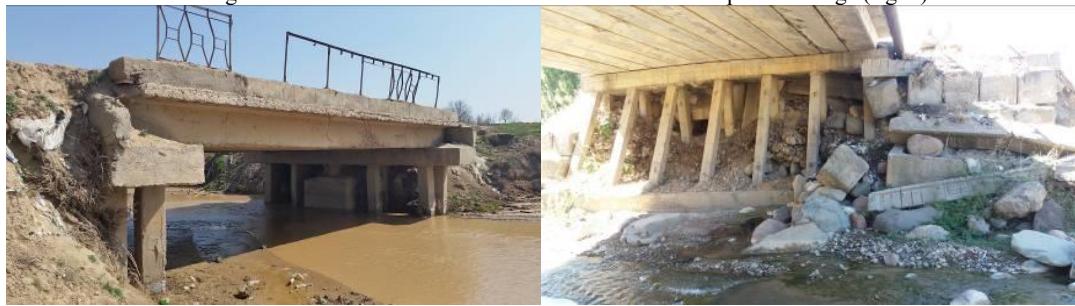
FIGURE 4. Soil subsidence due to insufficient compaction and soil washout from under transition slabs (Photo by Abirov R.)

Soil subsidence and inadequate compaction have led to damage in the approach roadbed and roadway thresholds around the transition slabs. This damage is primarily caused by soil subsidence as a result of insufficient compaction and soil erosion occurring beneath the transition slabs and cross beams due to poor drainage (fig. 4).

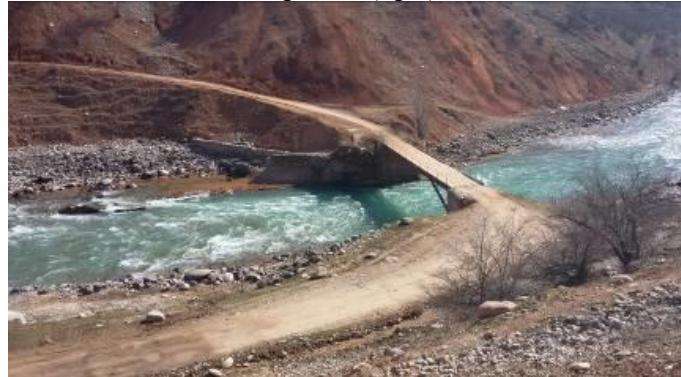
FIGURE 5. General view of the investigated site (Photo by Abirov R.)

Below proposed approach for installation of gabion structures in the working design for the bridge across the Pskem River at the exit to the settlement of "Ispai" from the 4K795 "Chorbog Suv Ombori Aylanma Yuli - Korabulok Village - Pskom Village" highway (fig. 5).

The existing bridge across the Pskem River at the exit to the village of Ispai was built by residents using the "hashar" method. In 2014, due to high water flow and long-term deformation of the riverbank slopes, the foundations of the bridge's bank piers were washed away.

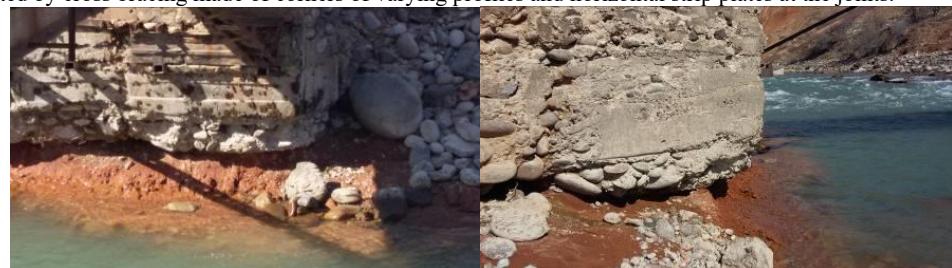
FIGURE 6. General view of the locations and conditions of bridge supports (Photo by Abirov R.)

Following a survey, the bridge was deemed unsafe, and it was proposed to replace the roadway and begin construction of reinforcement structures on the bridge banks (fig. 6).

The design was based on topographic and geodetic data compiled by the survey department of Loyikha Sifat LLC in March 2015. The design envisages the preservation and use of the existing superstructure, with the reinforcement of the bridge banks using gabion boxes. The piers are massive, cantilevered. The existing superstructure consists of composite I-beams with a total height of 77 cm. The distance between the beams is 232.5 cm. The main beams are connected by cross bracing made of corners of varying profiles and horizontal strip plates at the joints.
