Prevention of longitudinal tearing of conveyor belts

Lazizjon Ataqlarov, Shokhidjon Haydarov, Izzat Rakhmonov ^{a)}, Orifjon Kaxxarov

Navoi State Mining and Technological University, Navoi, Uzbekistan

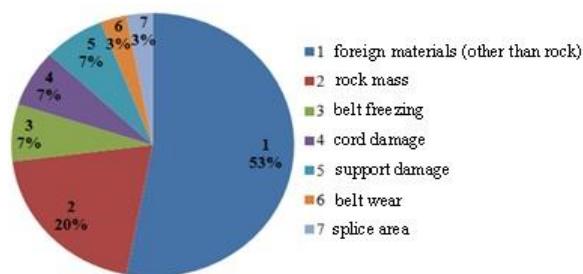
Main Part. During the operation of conveyor transport, stoppages occur as a result of belt damage caused not only by rock material but also by foreign objects (often sharp metal), accounting for 53% of downtime. Damage caused by rock material itself accounts for 20%, climatic changes for 7%, changes in the internal structure of the belt for 7%, breakage of roller supports or conveyor frames for 7%, belt abrasion for 3%, and rupture of connected sections of the belt for 3% (Figure 1) [1-10, 19-28].

FIGURE 1. Factors causing downtime due to belt damage

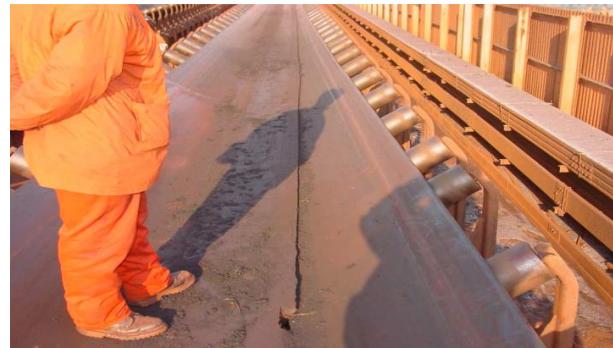
To detect longitudinal tears in conveyor belts, various monitoring technologies are employed worldwide. These include ultrasonic, laser, thermal imaging, and mechanically operated inspection devices. To prevent longitudinal tearing and mitigate the aforementioned risks, it is essential to stop the conveyor in a timely manner using belt monitoring and control systems. An example of a longitudinally torn belt during operational use is illustrated in Figure 2.

FIGURE 2. Longitudinal Tear in Conveyor Belts

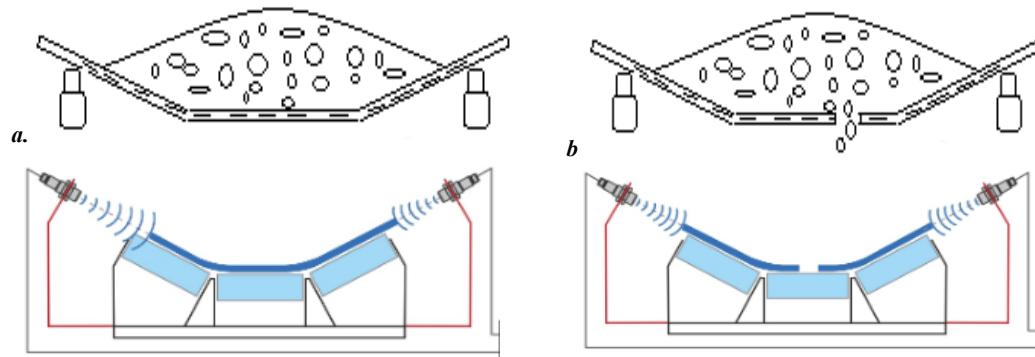
Ultrasonic Sensor Device for Conveyor Belt Monitoring. In the ultrasonic sensor device for monitoring conveyor belts, as shown in Figure 3a, piezoelectric plates are installed on opposite sides of the belt. One plate generates waves across the belt width, while the other plate, located on the opposite side, receives the waves. In Figure 3b, when the belt is longitudinally torn, the waves sent by the transmitting piezoelectric plate cannot pass through the torn section to reach the receiving plate. As a result, the sensor emits a signal sound and stops the conveyor.

FIGURE 3. Detection of Belt Tear Using an Ultrasonic Sensor
a – Wave propagation across the belt width; b – Longitudinal tear of the belt

In this case, if the belt is longitudinally torn, the second plate will not receive the waves, indicating that the belt has been damaged [2].

All devices currently used worldwide to detect longitudinal belt tears have their respective advantages and disadvantages. The drawback of ultrasonic sensors is that they activate only when the belt is completely torn through its thickness; in other words, a partial tear does not interrupt wave transmission across the belt width, so the conveyor does not stop until the tear becomes full-depth. Laser sensors, while accurate, are expensive, and their

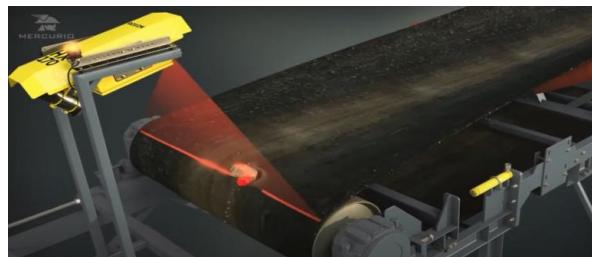
The analysis of using laser sensor devices shows that the recommended method is effective for detecting longitudinal cracks wider than 3 mm. That is, before the belt develops a longitudinal tear, the objects causing the damage may first create slight scratches on the belt surface. Signals generated by these scratches are displayed in the

monitoring software, and depending on their magnitude, the conveyor can be stopped or allowed to continue operating. Experimental results indicate that the detection accuracy reaches 99.2% (Figure 4) [4,6,7-30].

FIGURE 4. Laser Sensor Device

Moreover, compared to image processing methods used to detect longitudinal or transverse tears—which require approximately 18–50 m/s—this method has a significantly shorter identification time of 0.01–0.04 m/s.

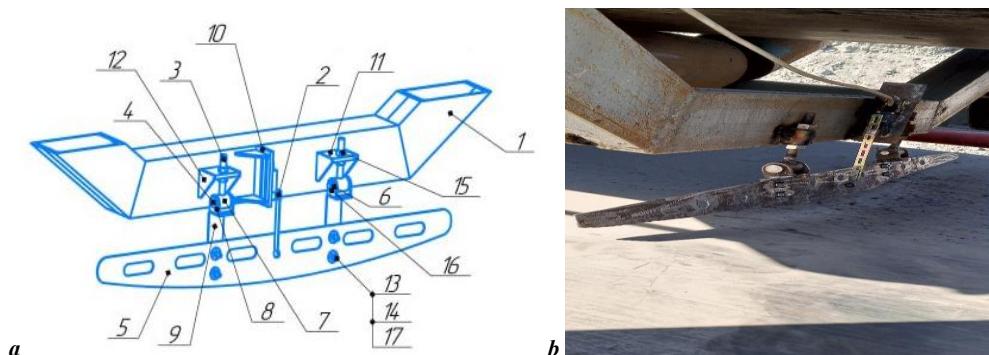
First, a structural diagram of the mechanical monitoring device for detecting longitudinal belt tears was developed (Figure 7). The structural diagram consists of the following components:

1 – conveyor transverse lower frame (existing on the conveyor); 2 – limit switch; 3 – pin; 4 – lever arm; 5 – transverse metal plate; 6,7 – bushings; 8,16 – cotter pins; 9 – metal lever; 10 – steel plate; 11,12 – brackets; 13,14,15,17 – bolts and nuts.

FIGURE 7. Mechanical Device for Monitoring Longitudinal Belt Tears
(a – Structural diagram; b – Developed device)

1 – conveyor transverse frame; 2 – limit switch; 3 – pin; 4 – lever arm; 5 – transverse metal plate; 6,7 – bushings; 8,16 – cotter pins; 9 – metal lever; 10 – steel plate; 11,12 – brackets; 13,14,17 – bolts and nuts; 15 – nut.

At the Muruntau open-pit mine, a belt tear monitoring device was installed on the lower idle branch of the KL-3 belt conveyor at the Continuous Transport Department (CTD) (Figure 7). The steel plate (10) and brackets (11, 12) are welded to the transverse frame (1) of the conveyor. The limit switch (2) is fixed onto the steel plate. A pin (3) is mounted on the brackets, allowing adjustment of the transverse metal plate (5) upward or downward using the nut (15). The lever of the limit switch (2) is positioned vertically and remains in contact with the transverse metal plate (5). When rock material hits the transverse metal plate (5), causing it to deflect at an angle of 15–20 degrees, the limit switch (2) is activated, which ensures the conveyor stops automatically.

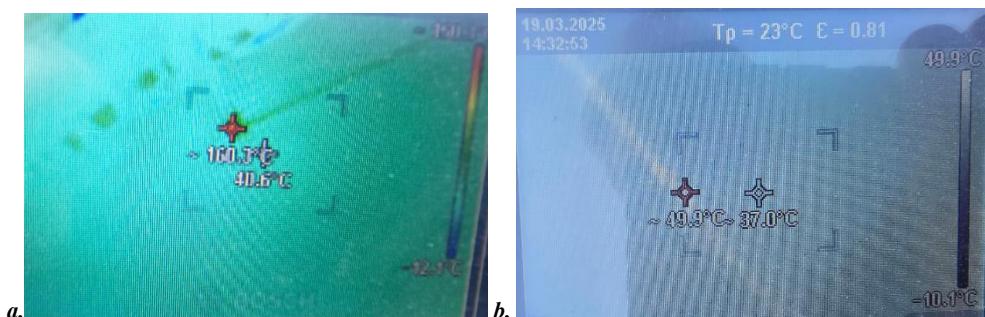
The resulting images are shown in Figure 8. In Figure 8a, before the belt was torn, it can be seen that the sharp-edged metal heated up to 160.3 °C, while the belt temperature reached 40.6°C.

FIGURE 8. Images Obtained from the Thermal Imager
(a – Temperature of the belt and the sharp-edged metal; b – Temperature of the belt and the torn section of the belt)

In the next stage, as a result of the sharp-edged metal completely cutting through the belt, a temperature change occurred along the torn section of the belt, as shown in Figure 8b. The temperature along this line reached 49.9 °C, while the temperature of the remaining belt was 37°C. This indicates that the sharp-edged metal that caused the tear heated up, and the temperature difference between the torn section and the intact belt reached 13 °C.

Additionally, at the Heap Leaching Plant under the Central Mining Administration of NMMC, an experimental study was conducted using a thermal imaging device to investigate complete longitudinal tearing of a conveyor belt. For this experiment, a fabric belt with a width of $B = 1200$ mm and a thickness of $h = 40$ mm was used. The belt was installed on a mobile conveyor (Kuznechik) and set in operation. The conveyor speed was $v = 3$ m/s, and a sharp-

edged piece of metal was used to induce tearing. The sharp metal completely cut through the belt, causing a longitudinal tear, while a thermal imaging device was installed under the lower side of the belt.
